# Conservation of Dalle de Verre at the New York Hall of Science

RAYMOND M. PEPI, LAURA N. BUCHNER, AND CHRISTOPHER GEMBINSKI

**The conservation of more than 5,000 concrete dalle-de-verre panels in a structure built for the 1964 World's Fair reanimated a luminous construction designed to inspire space exploration.**

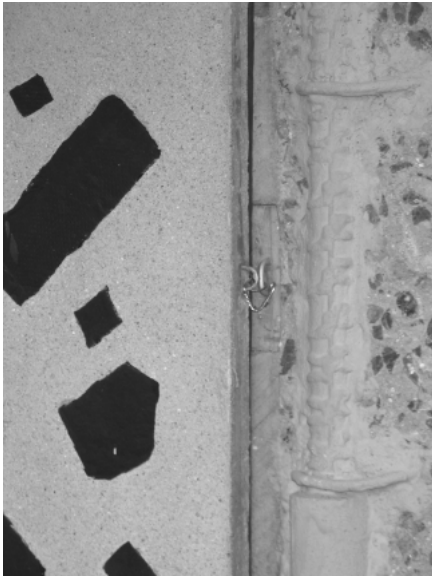
Fig. 4. Attachment of dalle-de-verre panel to cast-in-place concrete, 2010. The concrete on the left side of the image was demolished, and the steel reinforcement was cleaned and coated with a rust-inhibitive coating in preparation for patching.

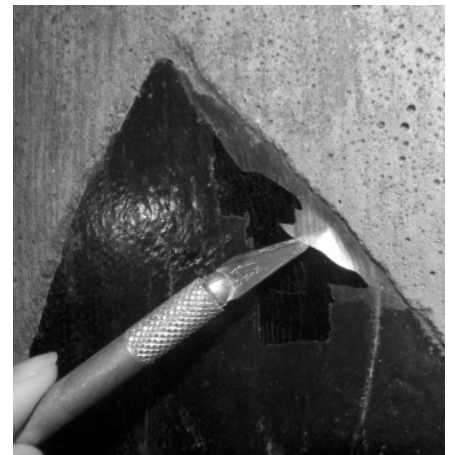
Inside the lobby of the Great Hall original panels that were set flush with the cast-in-place concrete exhibited a translucent yellow film coating their surface (Fig. 5). The film was found to be flaking from the glass, as well as from the precast concrete. On the exterior of the building, small flakes of this brittle material could be seen on panels in areas protected from weathering due to the presence of the free-standing wall that overlaps part of the facade. The coating apparently weathered more on surfaces with greater exposure to the elements.

Samples of the coating were removed from interior panels and subjected to Fourier transform infrared spectroscopy (FTIR). The infrared spectra of this coating exhibited features consistent with a mixture of materials, including epoxy and a phthalate-based material. Phthalates are used to plasticize certain polymers (including epoxy) but are also used to make alkyd resins. It is not known if the phthalate was used as a plasticizer in epoxy, in a mixture of epoxy and alkyd, or in both. A cross section of the coating that was examined using fluorescence microscopy revealed a single discernible layer of the material.<sup>22</sup> This layer is likely the Benesco epoxy applied by Willet Studios as a waterproofing material.<sup>23</sup> Benesco was formulated for making cast panels, and it is possible that it was modified with a plasticizer to make it flow better as a coating.<sup>24</sup>

Fig. 5. Translucent coating degrading on interior dalle-de-verre panel, 2009.

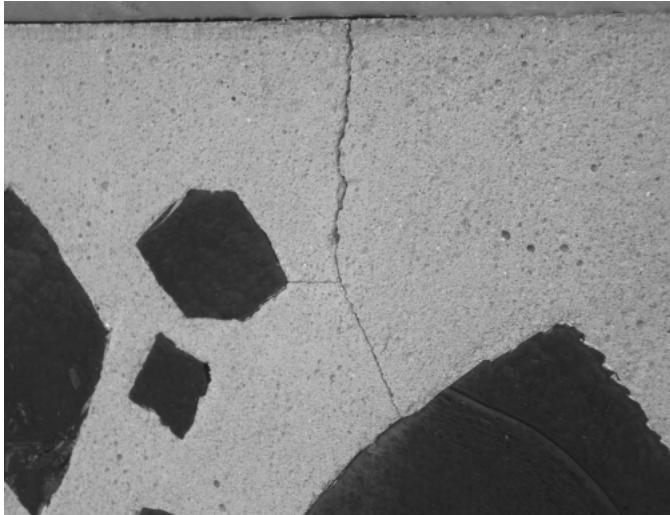
Fig. 6. Typical crack in a dalle-de-verre panel, stretching from glass to the edge of the panel, 2009.

Cracks radiate from some of the glass dalles to the concrete edges of the panels and are common at locations where wire ties were embedded for attachment to the cast-in-place concrete (Fig. 6). Many of these cracks penetrate the full depth of the panel and are visible on the interior of the building. These cracks, as well as spaces in between the dalles and the matrix, allow water penetration through the panels and contribute to water staining on the interior surfaces. Some panels have also been punctured by electrical, mechanical, and security equipment. The wire reinforcement in the panels successfully holds together the most severely cracked panels (Fig. 7).

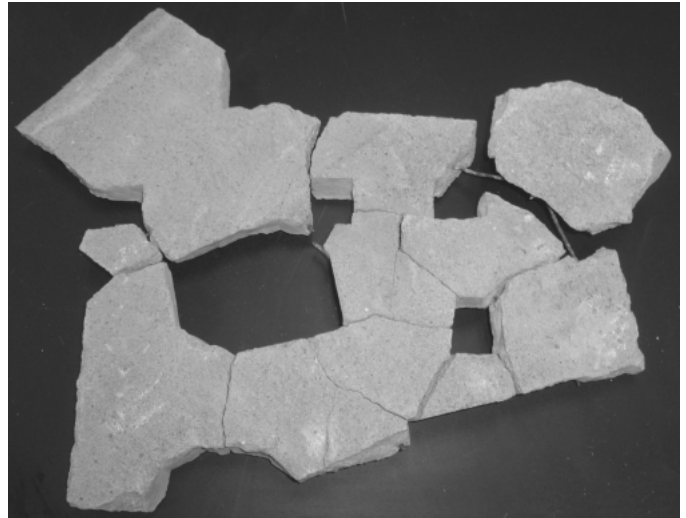
Fig. 7. Deteriorated panel that was broken apart in order to test the concrete and glass, 2009. Steel reinforcement made it difficult to separate the concrete fragments.

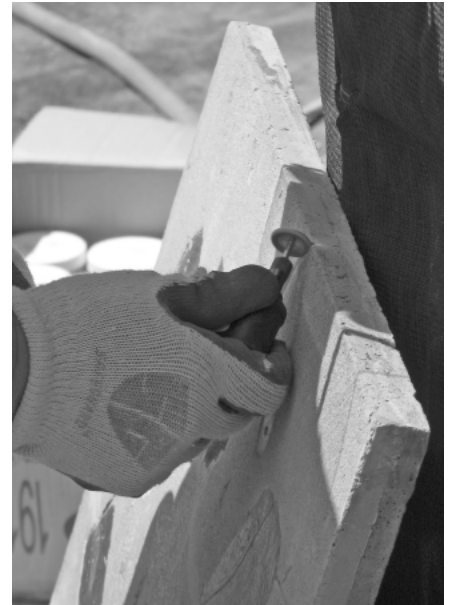
Fig. 8. Routing a crack in a panel as part of cementitious patch repair, 2010.

Due to the time constraints associated with the restoration and the large number of repairs to be performed, a singular approach to all cracks was desired to expedite work. Routing and filling cracks using a custom-color composite patching mortar was therefore considered, based on its known properties. Cathedral Stone Products, Inc., Jahn M90 concrete-repair mortar, already being used on site for the repair of the cast-in-place concrete, and Jahn M70 sandstone-repair mortar were tested. The Jahn M70 was eventually selected for the crack repair in the panels because it has finer aggregate than the Jahn M90 and a better working consistency for filling narrow cracks.

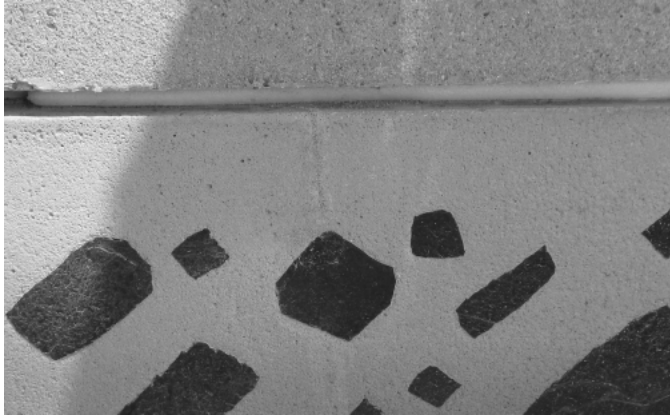
Fig. 9. Crack repair in a panel using cementitious patching material with surface-applied aggregate, 2010.

Cracks thinner than 0.75 millimeters in the panels were generally not repaired; this category included hairline separation between stable dalles and the pre-cast concrete matrix.<sup>57</sup> Cracks wider than 0.75 millimeters in sound exterior panels were treated with rout-and-fill repairs. Cracks were routed with custom-made, 22-millimeter diameter, 1/8-inch thick, diamond-tipped Dremel blades to a minimum depth of 3/8 inch and were then filled with the patching mortar (Fig. 8).<sup>58</sup> This mortar was also employed for patching holes in the panels where conduits were removed.<sup>59</sup> An aggregate blend was pressed into the surface of the patching mortar to match

adjacent concrete colors and textures (Fig. 9).<sup>60</sup> This procedure was used to repair approximately 4,000 cracks.<sup>61</sup>

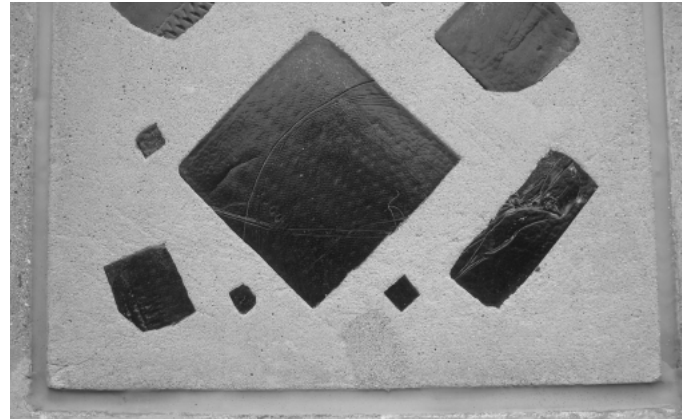
Fig. 10. The surface of a patch repair at center bottom of panel was coated with aggregate and Fixativ to further conceal the patch, 2010.

Although the original panels at the Hall of Science were cast from a pre-packaged concrete mix, they exhibit a wide variation in colors. For efficiency, however, only two colors of patching mortar, a gray and a tan, were selected for the exterior panel repairs. At the surface of repairs in the bottom five levels of panels, which are at eye level, workers applied the aggregate blend and KEIM Fixativ consolidant over the patching material and adjacent concrete. This surface coating further blended the repairs (Fig. 10).

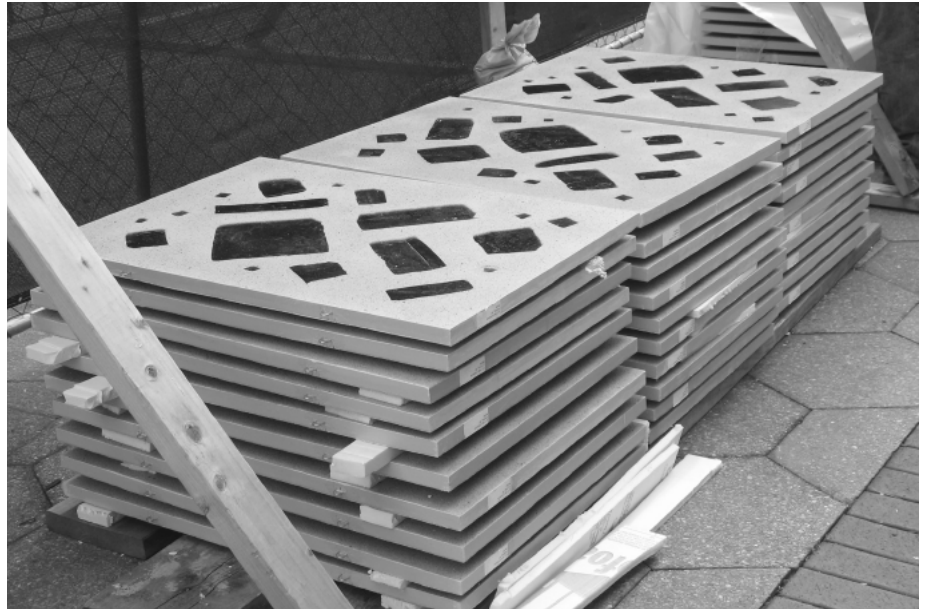
Fig. 11. New replacement dalle-de-verre panels with an epoxy matrix matching the exterior appearance of the original pre-cast concrete panels, 2009.

ple wide cracks, deflection, and/or damaged or destabilized glass were selected for replacement by the architect. The worst conditions were found at the parapet level of the building, where water had infiltrated behind the panels. Severe deterioration was also noted at the freestanding wall, where panels were exposed to weather on both sides.

The original manufacturer of the concrete panels, now called Willet Hauser Architectural Glass, produced new panels cast with an epoxy matrix to replace severely deteriorated panels (Fig. 11).<sup>65</sup> Two colors of epoxy were selected as matrix material for replacement panels. A mix of silica and mason sand was broadcast onto the surface of all the epoxy to simulate the appearance of the original concrete panels. Natural variations in the aggregate resulted in a range of tan and gray replacement panels similar to the original panels.<sup>66</sup>
