# Conservation of Dalle de Verre at the New York Hall of Science

RAYMOND M. PEPI, LAURA N. BUCHNER, AND CHRISTOPHER GEMBINSKI

**The conservation of more than 5,000 concrete dalle-de-verre panels in a structure built for the 1964 World's Fair reanimated a luminous construction designed to inspire space exploration.**

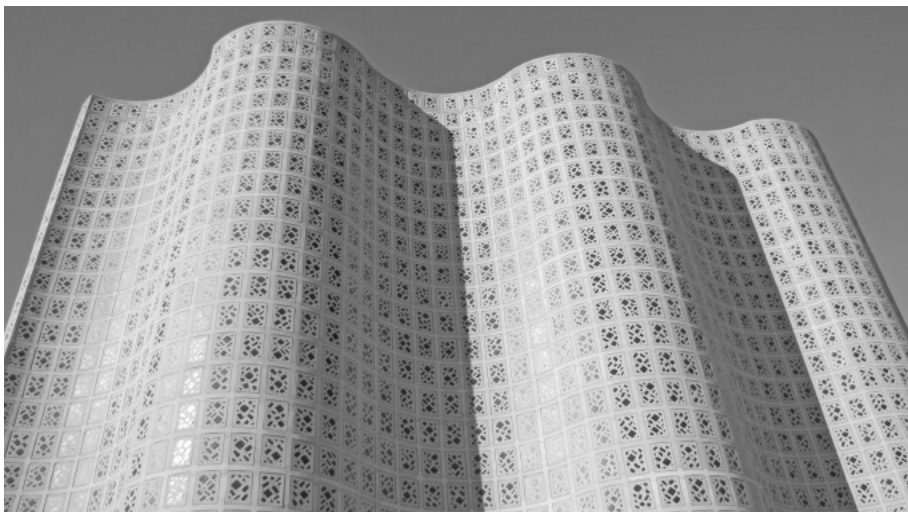
Fig. 1. New York Hall of Science, Queens, New York, built in 1965, exterior facade of the Great Hall in 2013. The dalle-de-verre panels are set in a cast-in-place concrete matrix. All images by the authors.

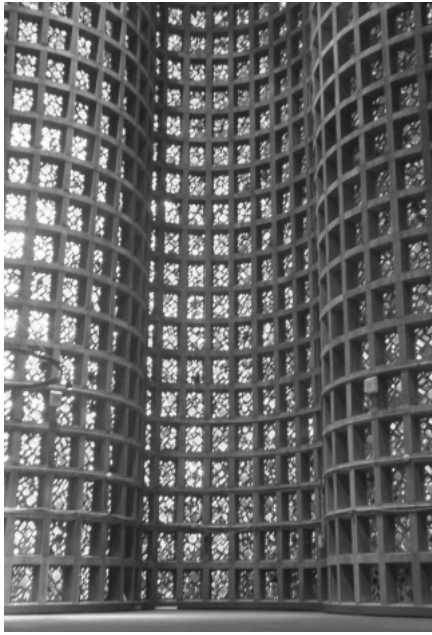
Fig. 2. Interior of the Great Hall before the interior upgrade, 2010.

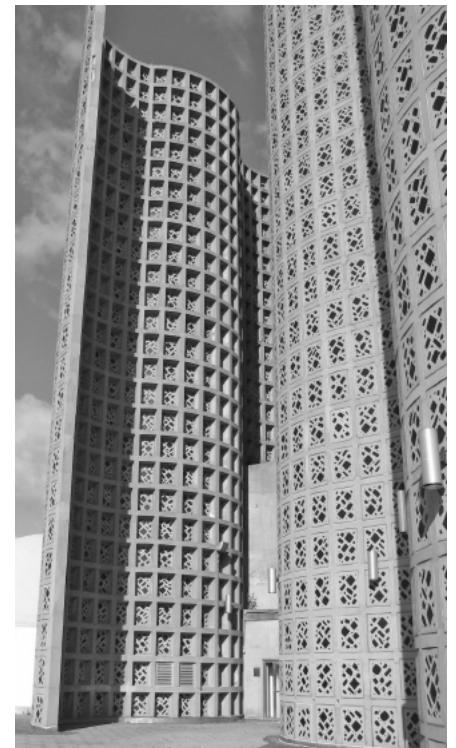
Fig. 3. The free-standing concrete wall at the left overlaps the undulating wall that encloses the tower, 2006. The entrance to the Great Hall is located below the solid concrete wall visible at the center of the photograph.
